HOOSIER BARN

**VOLUME 9, NO. 1
SPRING 2022**

Peru's Circus Winter Quarter Barns

English Barns on the Indiana Landscape

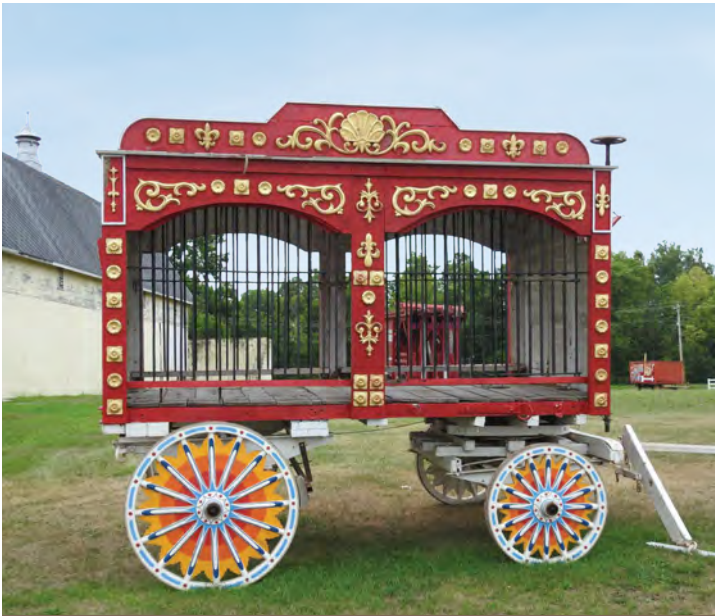
The red wagon cage was built in the Wagon Shop in 1924. The red wagon was used to house circus animals on display in the menagerie tent for visitors.

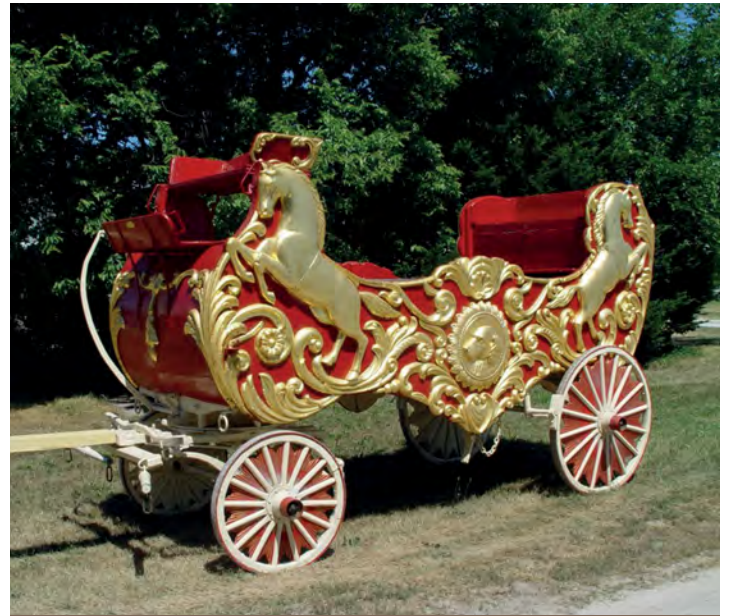
The Sig Sautelle Band Chariot was built by Sullivan and Eagle Company in Peru in 1887. The Band Chariot carried the band in the parades where they played music.

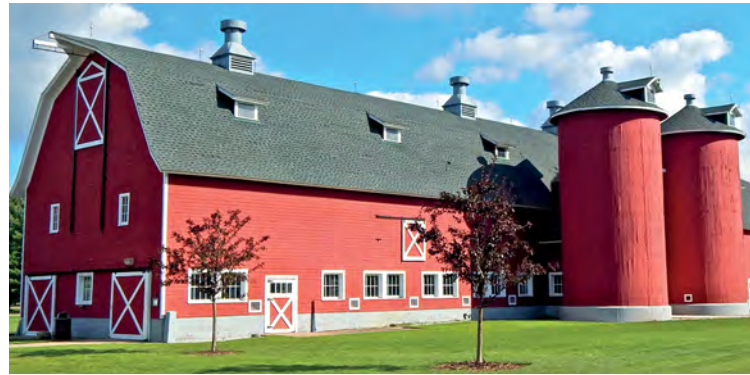
THE RED BARN AT SAINT PATRICK'S PARK was a dairy barn before becoming an event barn. The inside has been renovated, the exterior has the original barn doors, windows and silos. The Red Barn is the largest barn in St. Joseph County. It's listed on the Indiana Registry of Historic Places.

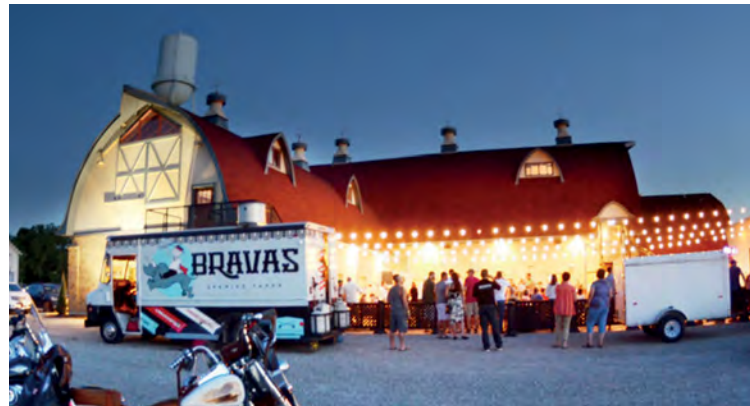
SYLVAN CELLARS EVENTS CENTER & TASTING ROOM is a family owned and operated events center and tasting room. Prior to Rachel and Nathan Schermerhorn purchasing the barn, it was listed as one of the top 10 most endangered historical landmarks in Indiana. The barn has been transformed into an event center while maintaining its rustic style with the barn's 30-foot high gabled ceilings and original wood floors.

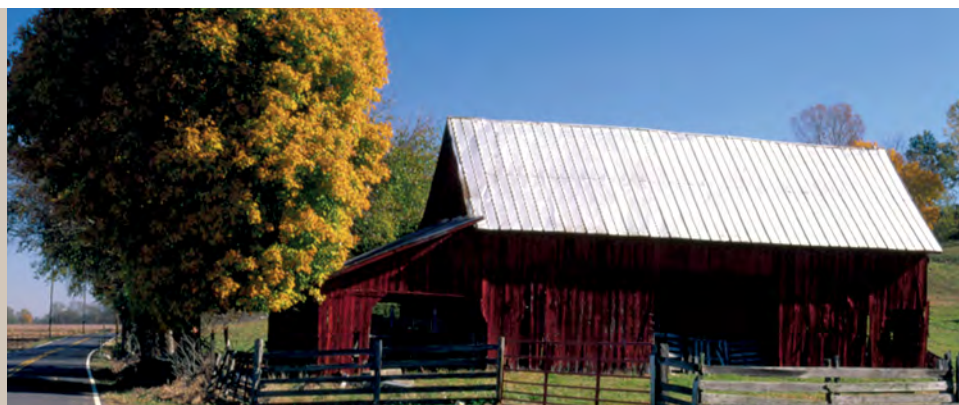
The traditional English barn is small, one-story, rectangular with a gable roof. It is typically located on level ground and not banked. The hinged wagon doors located on opposite sides of the eaves enter a central floor used for the threshing (thrashing) and winnowing of grain. The floorboards were fitted tightly to prevent the loss of grain. The doors provided cross ventilation that blew away the chaff during hand threshing, a process which lasted until about 1820. A high sill

— the threshold — prevented the grain from blowing out of the barn. The central threshing aisle is flanked by a bay on each side, a tie-up for livestock on one side and storage of grain, hay, straw, or sheaves, and often a stable, on the other side. Lofts for hay were located over the side bays. A small lean-to shed was sometimes added to the side of the barn. The first barns were without windows but after the early 1800's small windows were often added.
